Manhole Inspection Summary

Manhole # S02GG2008MH

Location Address: **3203 Fallstaff Rd**

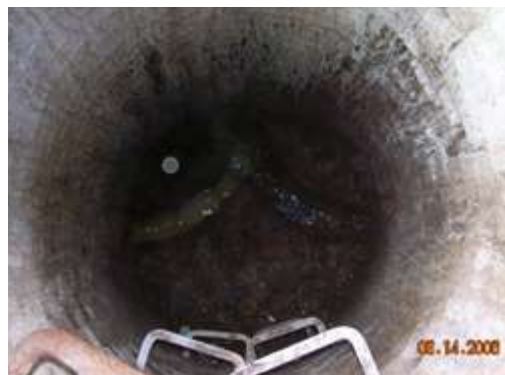
Top View

Comments **Heavy Calcification**

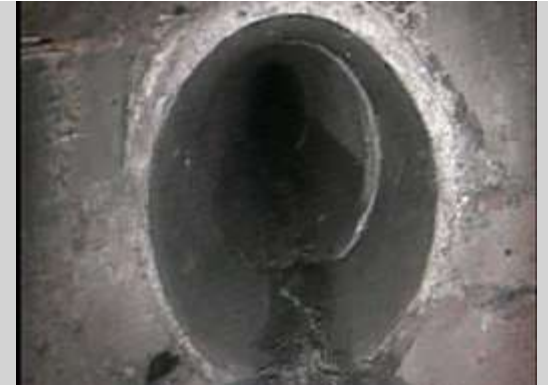
8 in. Circular Gravity Sewer Pipe Out @ 12 O'Clock

Pipe Material: **Clay** ☐ Pipe Lined

Invert Depth: **10.62** (ft.) Flow Characteristics: **Slow**

Deposits: ☒ None ☐ Mud ☐ Sludge ☐ Debris ☐ Grease

Infiltration: **None** Pipe Seal Cond: **Sound**

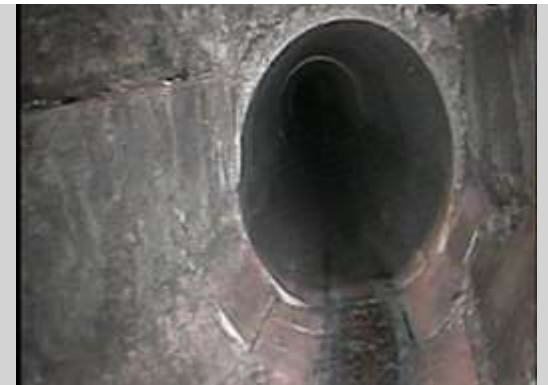
8 in. Circular Gravity Sewer Pipe In @ 3 O'Clock

Pipe Material: **Clay** ☐ Pipe Lined

Invert Depth: **10.50** (ft.) Flow Characteristics: **Slow**

Deposits: ☒ None ☐ Mud ☐ Sludge ☐ Debris ☐ Grease

Infiltration: **None** Pipe Seal Cond: **Sound**

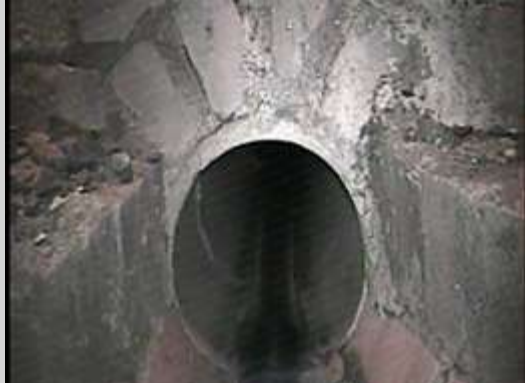
8 in. Circular Gravity Sewer

Pipe Material: **Clay**

Invert Depth: **10.61** (ft.) Flow Characteristics: **Slow**

Deposits: ☒ None ☐ Mud ☐ Sludge ☐ Debris ☐ Grease

Infiltration: **None**

Pipe Seal Cond: **Sound**
